RE: URS Project No. 05644-098  
NSP Ashland Lakefront Sediment – Clay Tile Investigation Report  
Xcel Energy, Inc., 301 Lake Shore Drive, Ashland, Wisconsin

# **FINAL REPORT**

## **CLAY TILE INVESTIGATION NSP/ASHLAND LAKEFRONT ASHLAND, WISCONSIN**

February 19, 2002

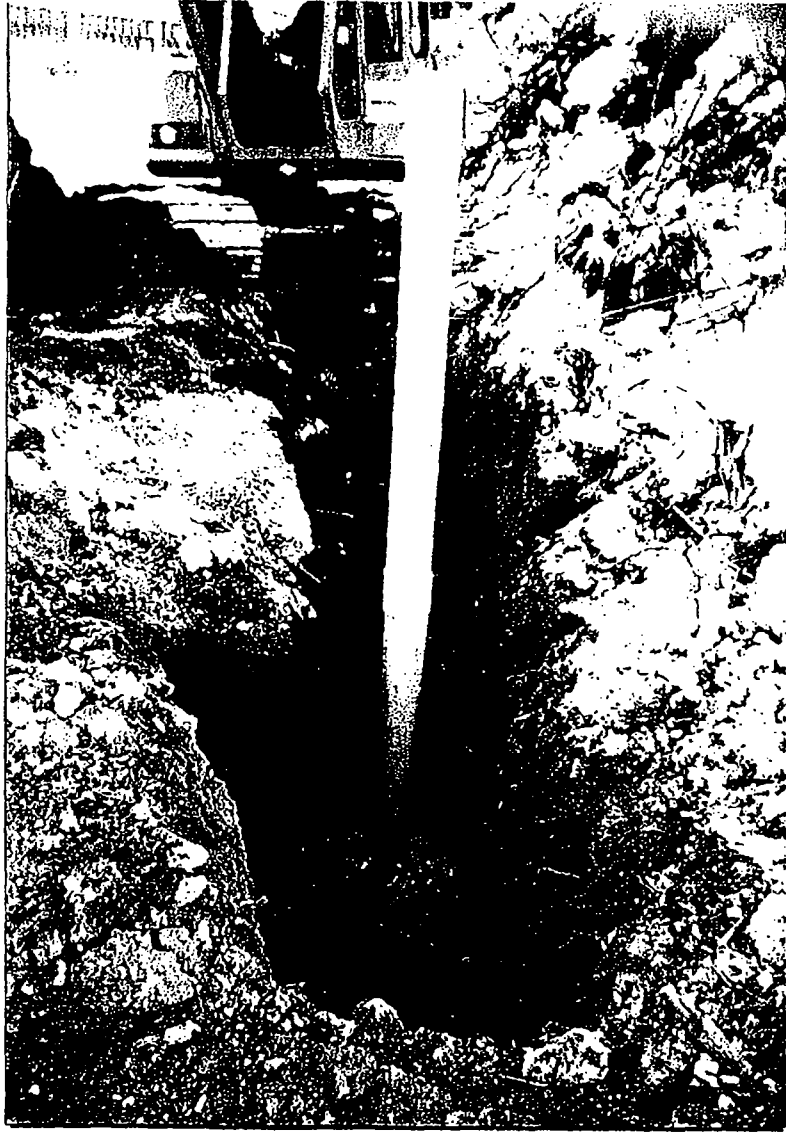
Photo 1- Installing riser pipe in trench back filled with gravel in seep area (February 2001)

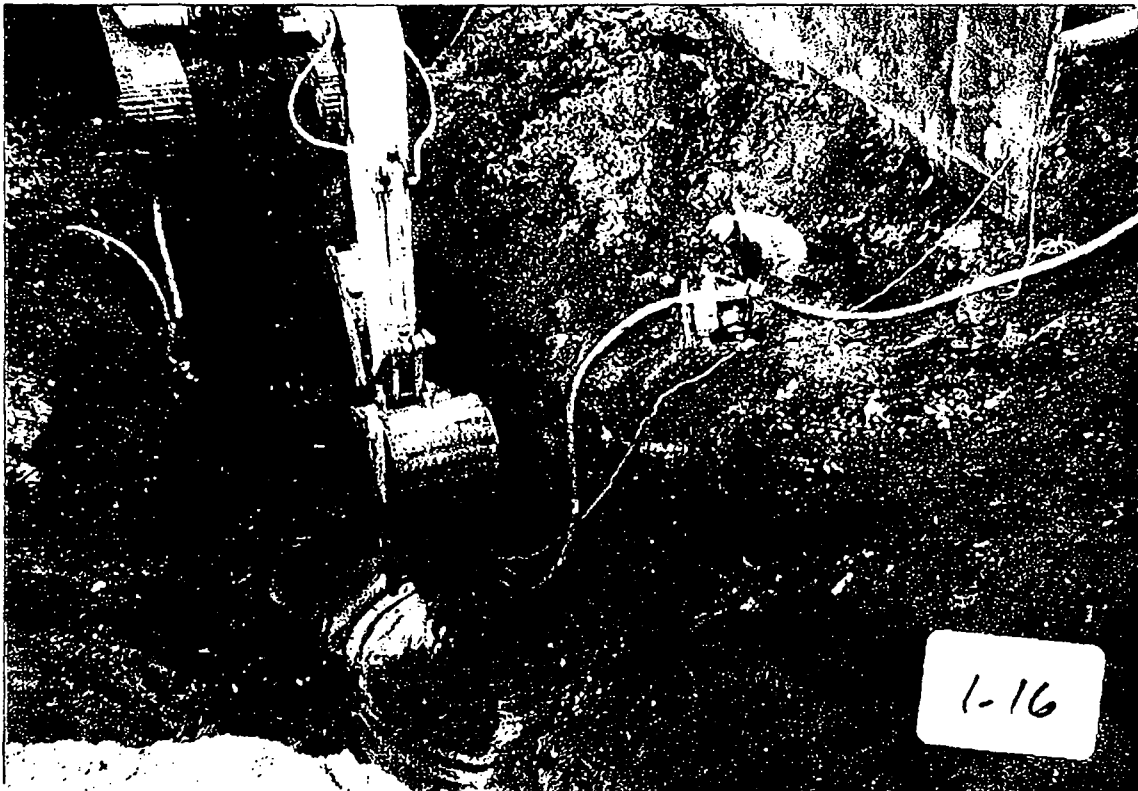
Photo 6 - Removing water that drained from clay tile from excavation. (September 19, 2001)

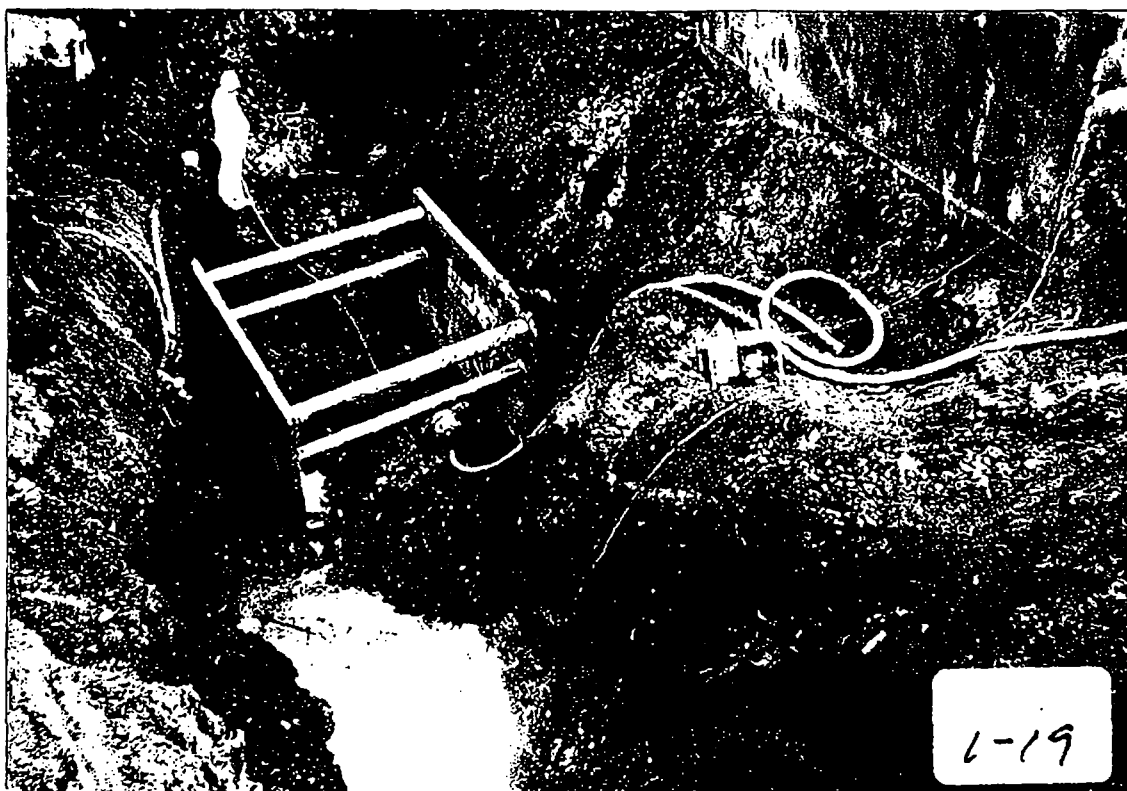
Photo 8 - Trench box placed above clay tile. Superior crew cleaning out clay tile prior to inserting probe. (September 19, 2001)

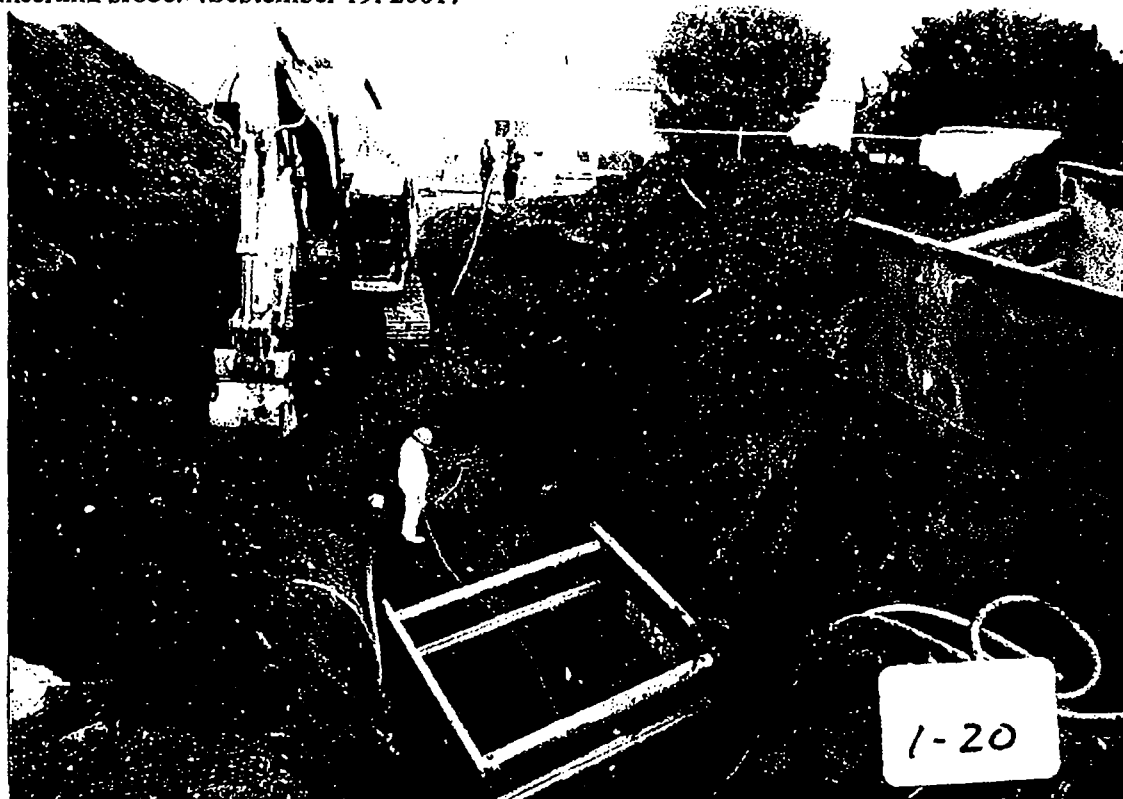
Photo 9 - Superior crew inserting probe into clay tile located beneath trench box. Probe being handed down from surface by Visu-Sewer crew. (September 19, 2001)

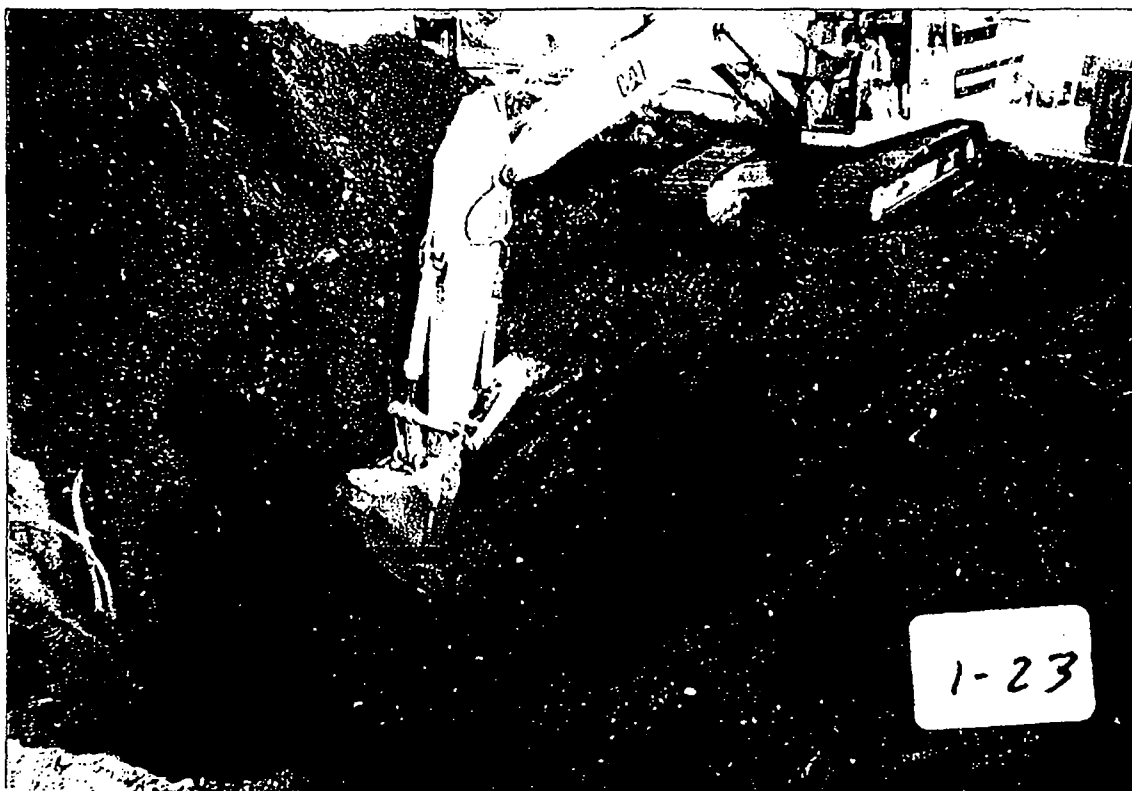
Photo 10 - Excavating along top of clay tile in area where probe could not be advanced any further. (September 19, 2001)

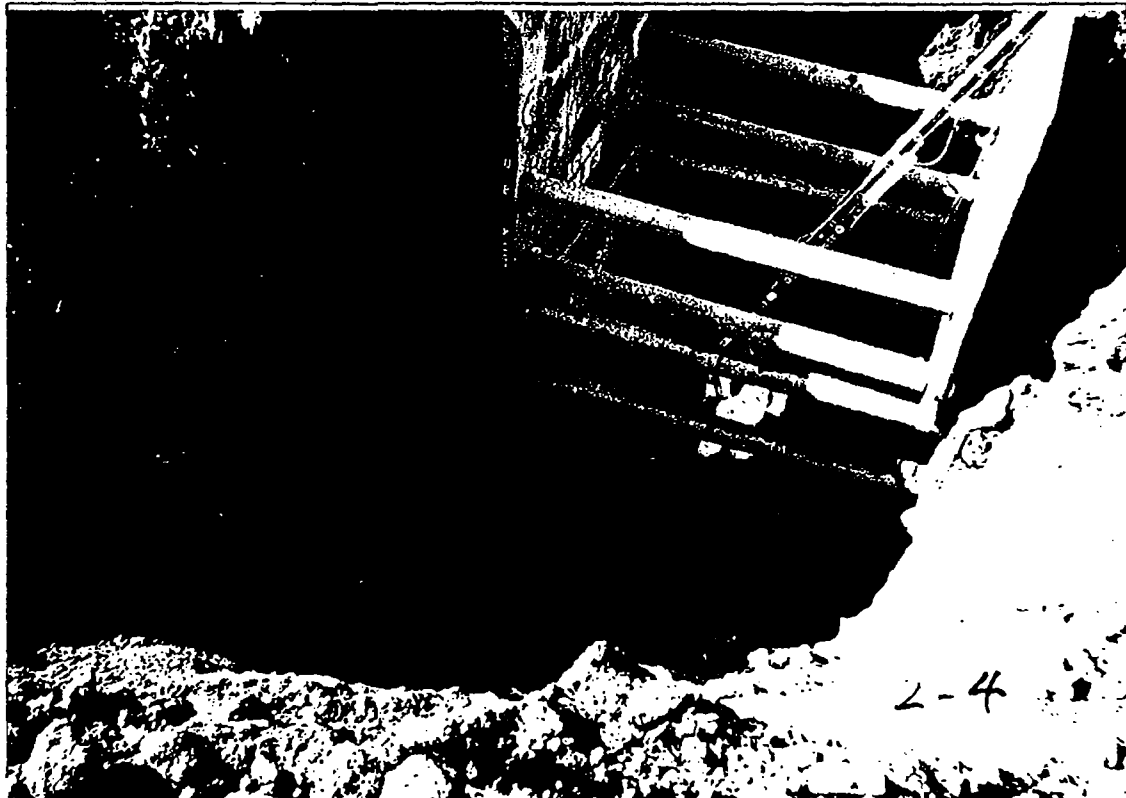
Photo 13 - Trench box placed on top of clay tile. Superior crew in trench box advancing probe into pipe which is being handed down from surface. (September 20, 2001)

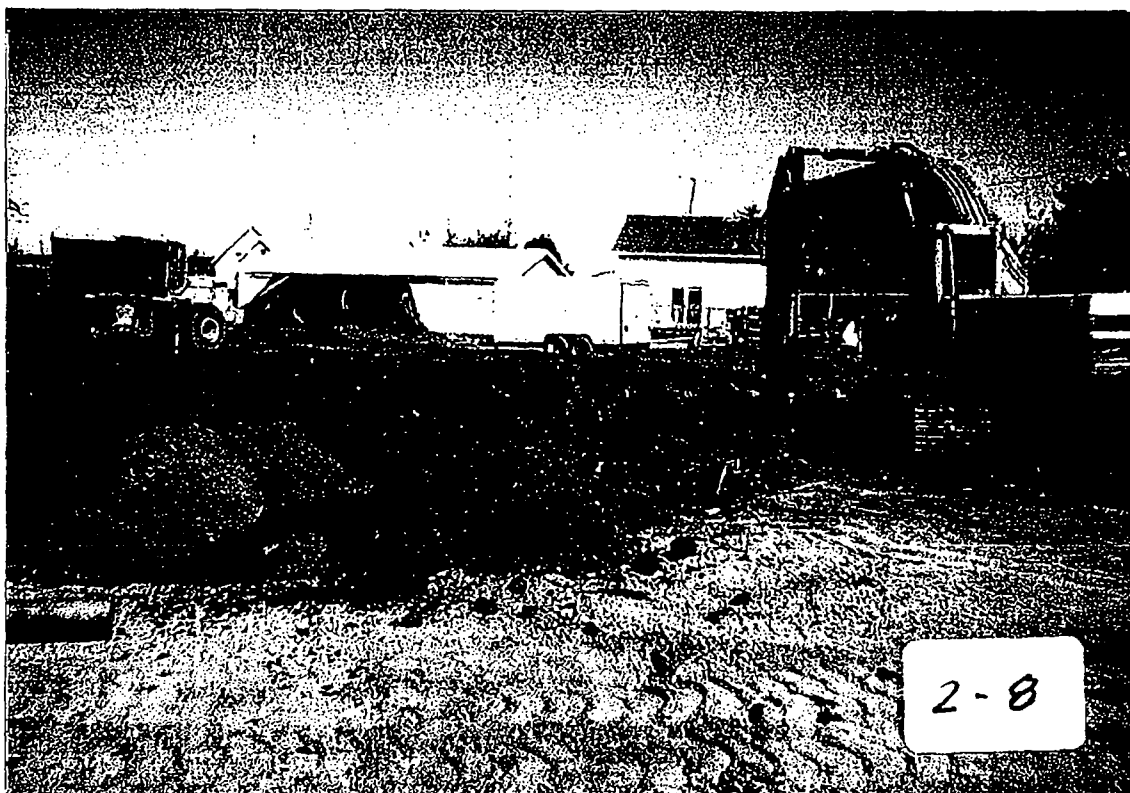
Photo 16 - Excavating to an approximate depth of 20 feet to locate well MW -2B which was destroyed when side wall of September 19, 2001 excavation collapsed. (September 20, 2001)
